**FINAL SITE INVESTIGATION AND ENGINEERING  
EVALUATION REPORT  
for the  
BOYERTOWN SANITARY DISPOSAL LANDFILL  
300 MERKEL ROAD  
GILBERTSVILLE, PENNSYLVANIA 19525**

**PADEP CONTRACT NO. ME-359186  
PADEP REQUISITION NO. 30-174**

**JUNE 2004**

**Tetra Tech FW, Inc.  
One Oxford Valley – Suite 200  
Langhorne, PA 19047 - 1829**

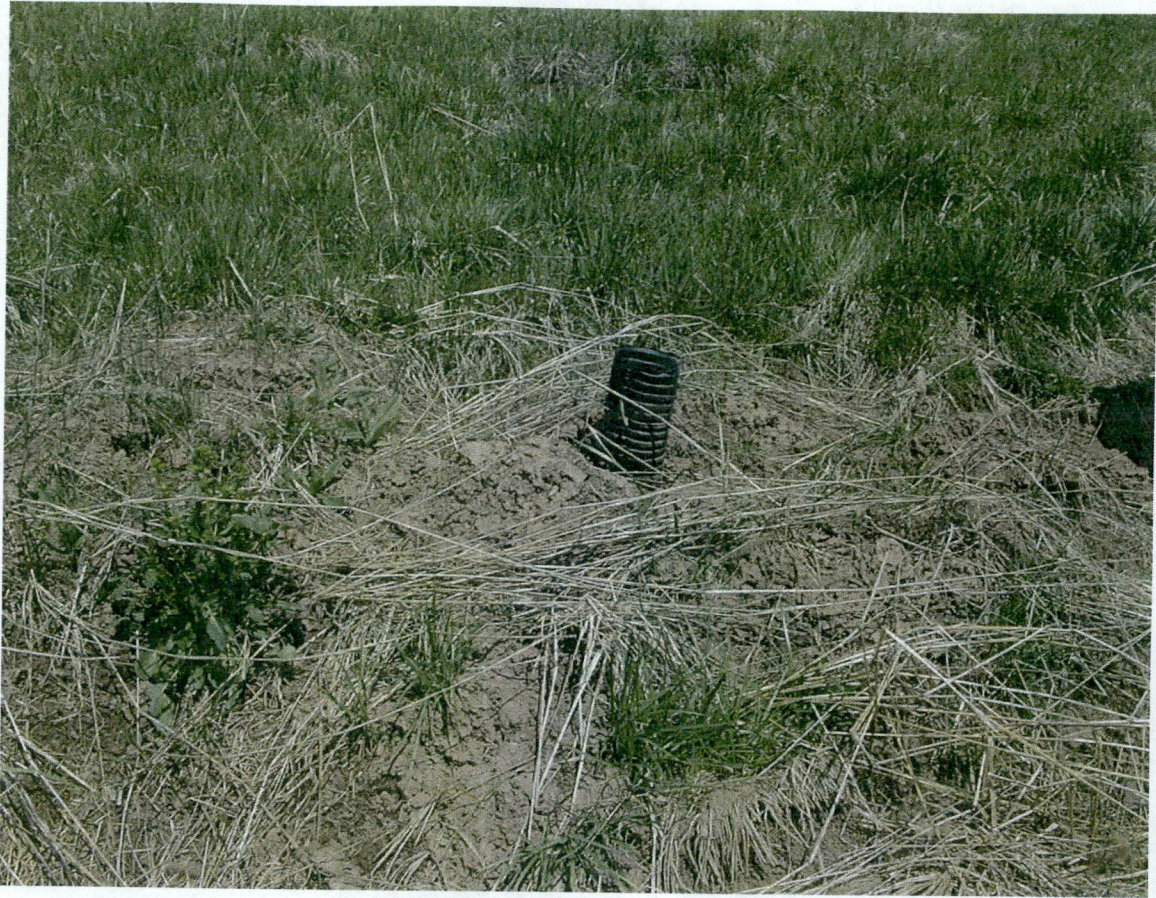
The original vapor recovery system was observed to be in disrepair along the south side of the landfill during the site visit. The system consists of various sections of above ground flexible corrugated HDPE (drainage tile) piping with some sections connected with duct tape. A portion of this piping was observed to be destroyed on the southern portion on the landfill; it appeared that the damage was caused by a vehicle being operated on the landfill. Fugitive emissions were noted in the vicinity of the piping, especially in the damaged areas.

**Photo #1 – View of damaged vapor recovery piping n the southern side of the landfill.**

TtFW suspects that the system installed by Shaw will assist in the reduction of fugitive emissions from the original vapor recovery system. However, the piping associated with the original vapor recovery system should be repaired and properly maintained to prevent fugitive emissions from reaching the neighboring community (residential homes are located directly adjacent to the southern side of the landfill) and to prevent short-circuiting of the Shaw system. The current flexible corrugated HDPE piping of the existing system should be replaced with rigid PVC or HDPE piping to provide durability.

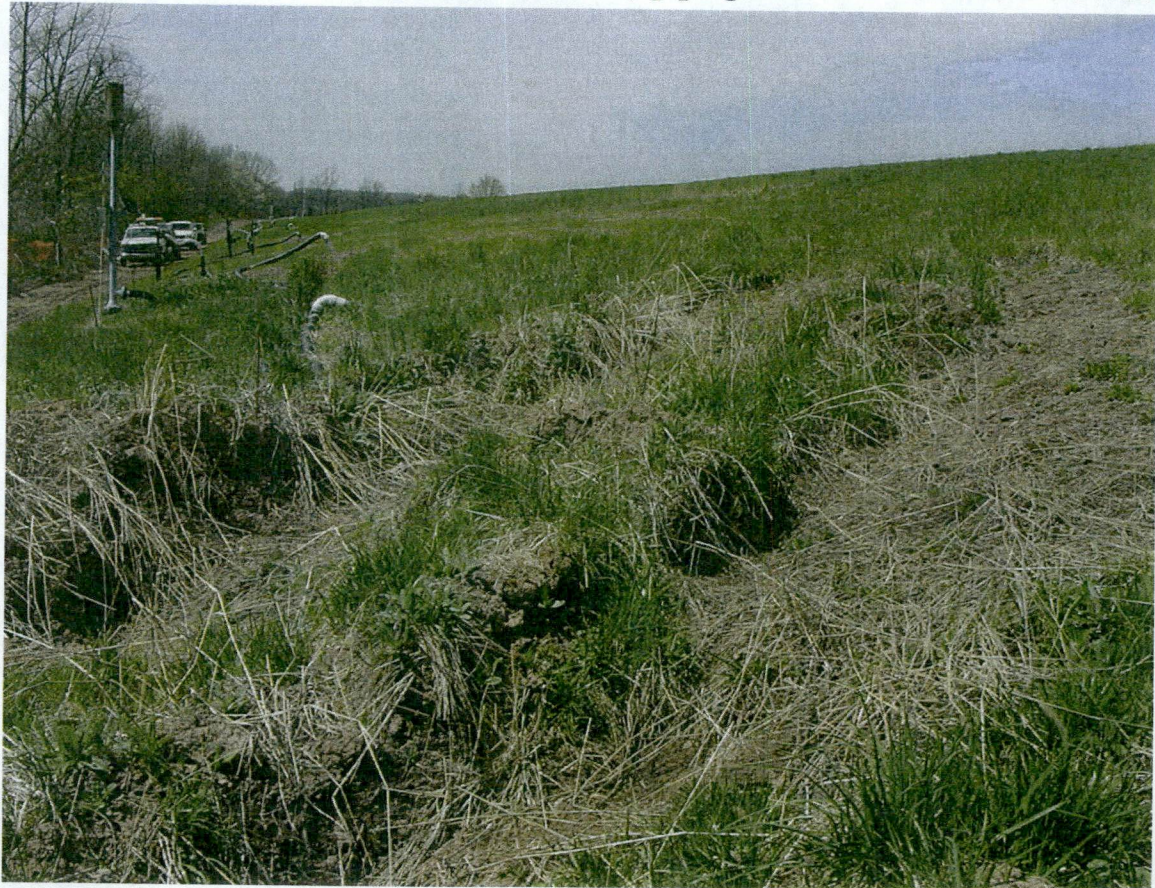
**Photo #2 – View of tire marks on the southern side of the landfill.**

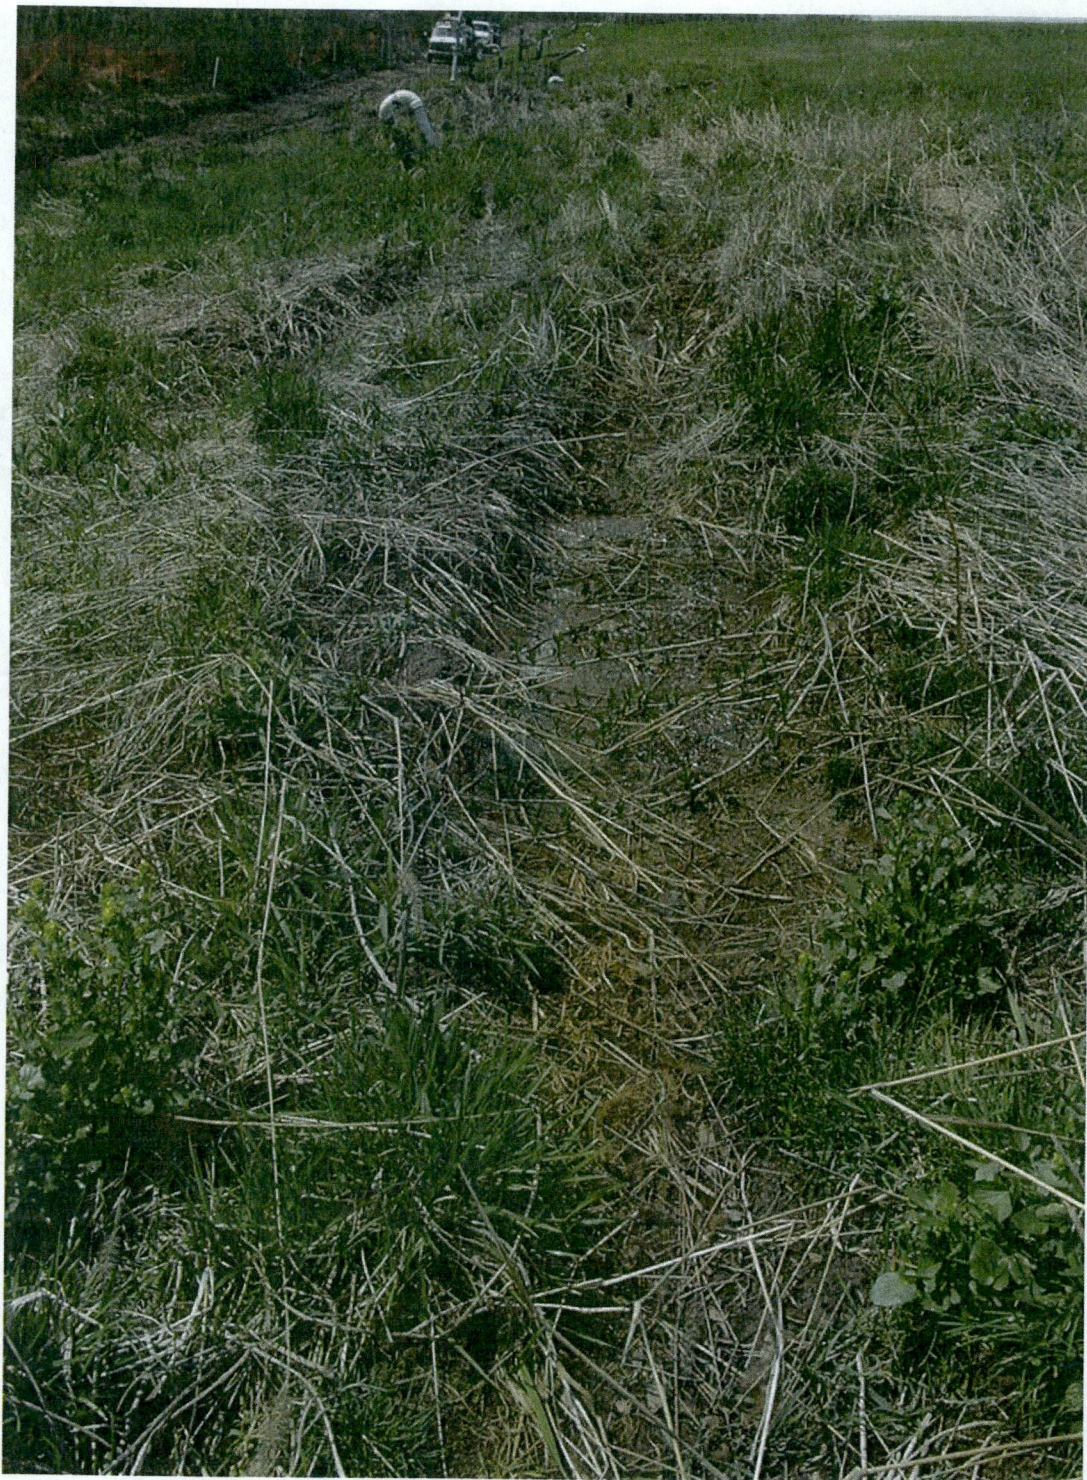
**Photo #3 – View of tire marks on the southern side of the landfill.**

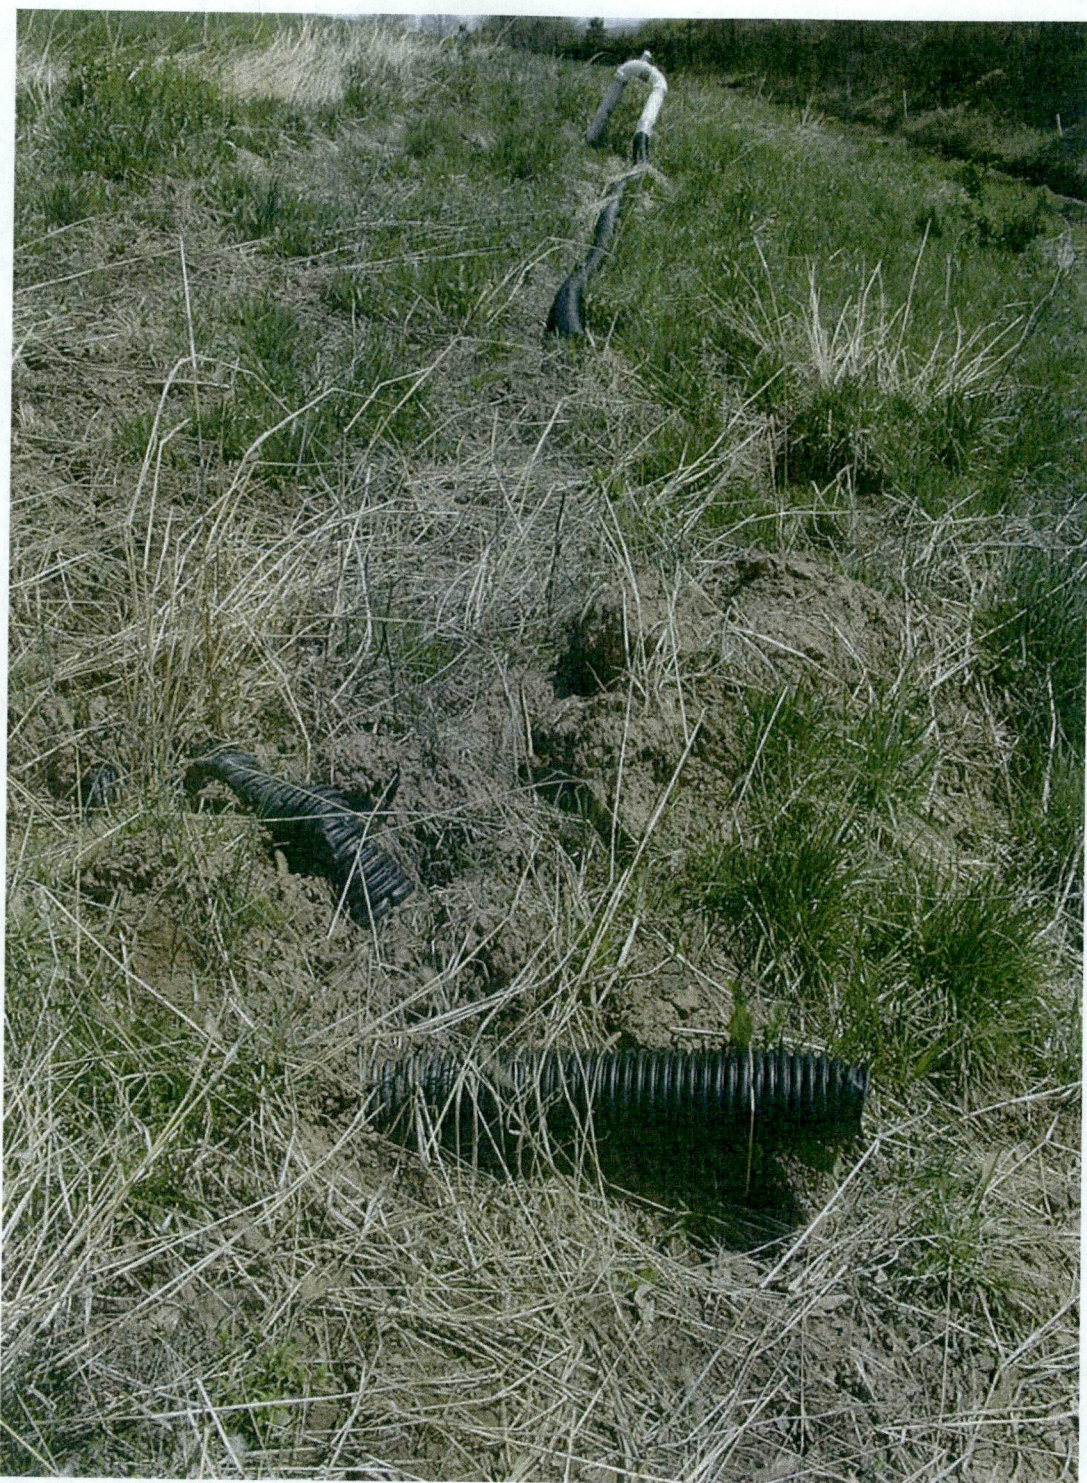
**Photo #4 – View of damaged piping associated with the original vapor recovery systems on the southern side of the landfill.**

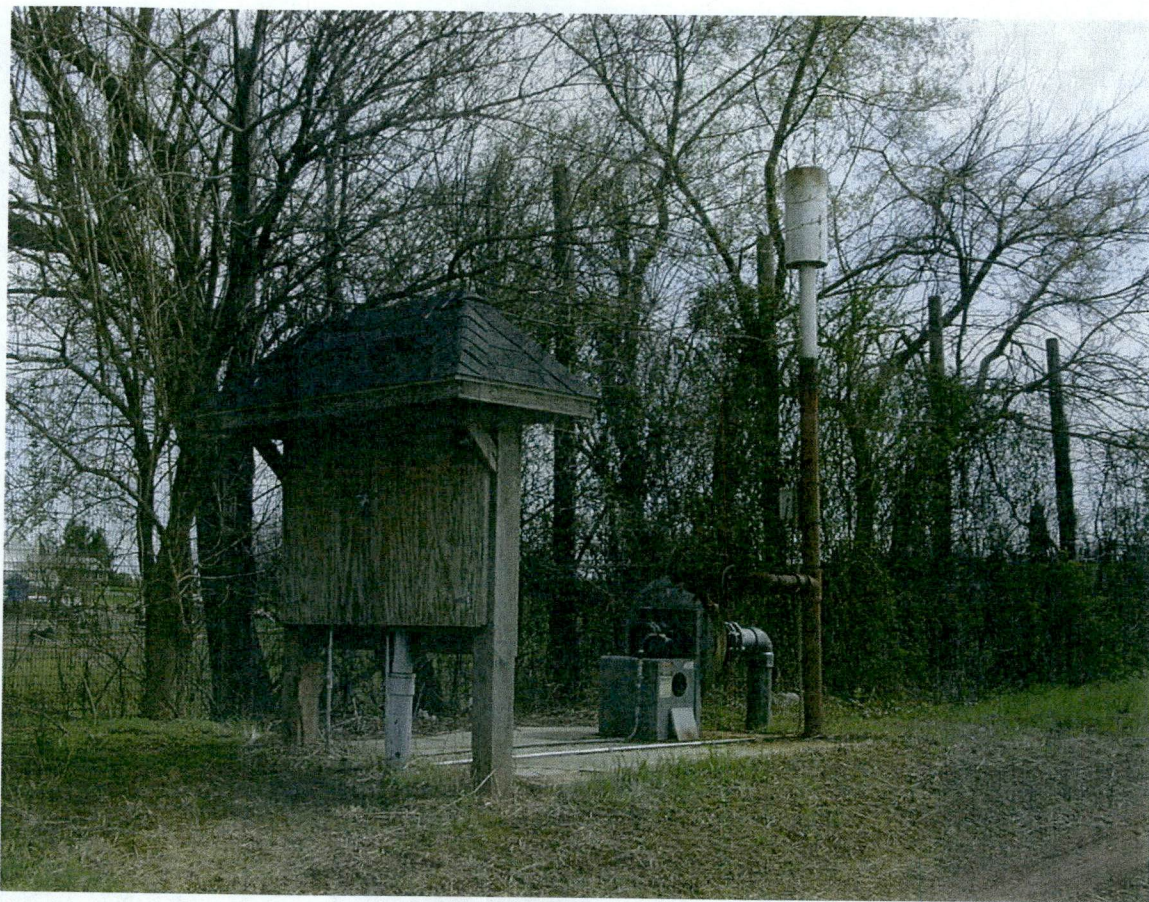
**Photo #5 – View of original vapor recovery system at southeast side of the landfill (not in operation).**

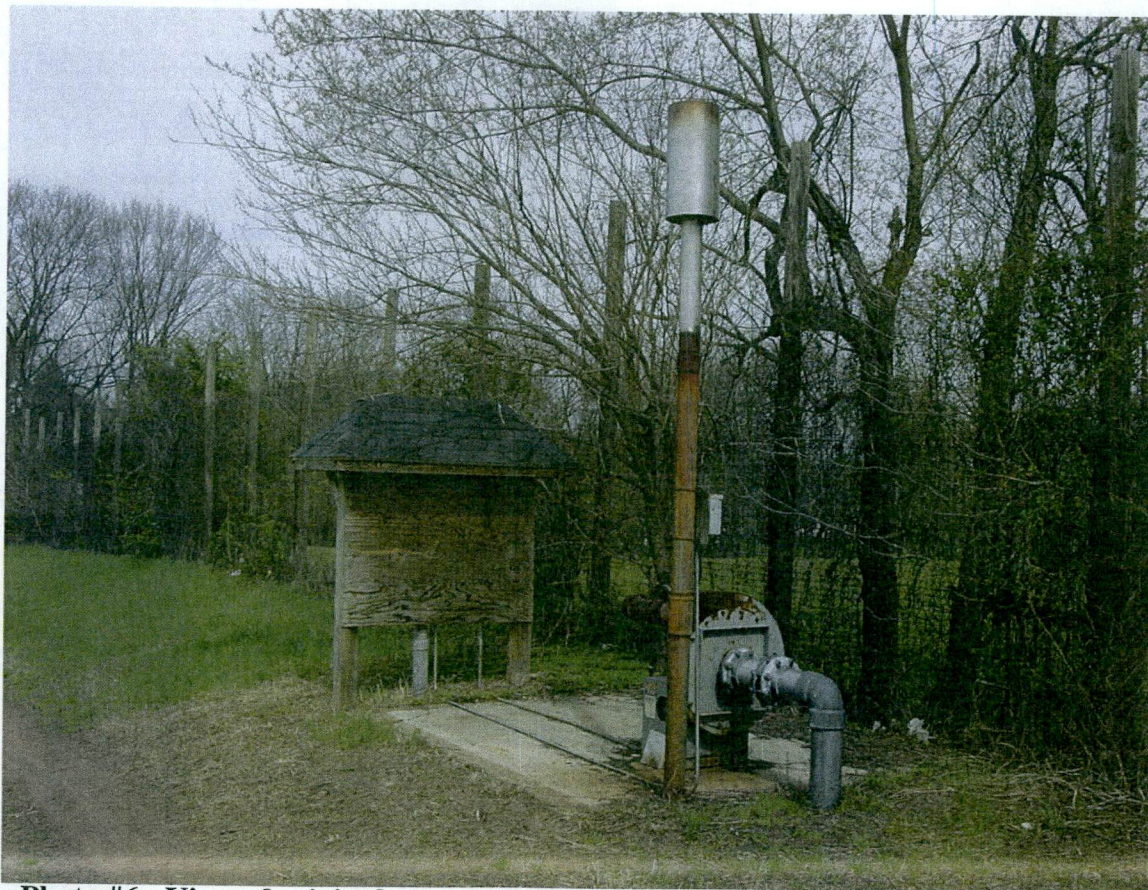
**Photo #6 - View of original vapor recovery system at southeast side of the landfill (not in operation).**

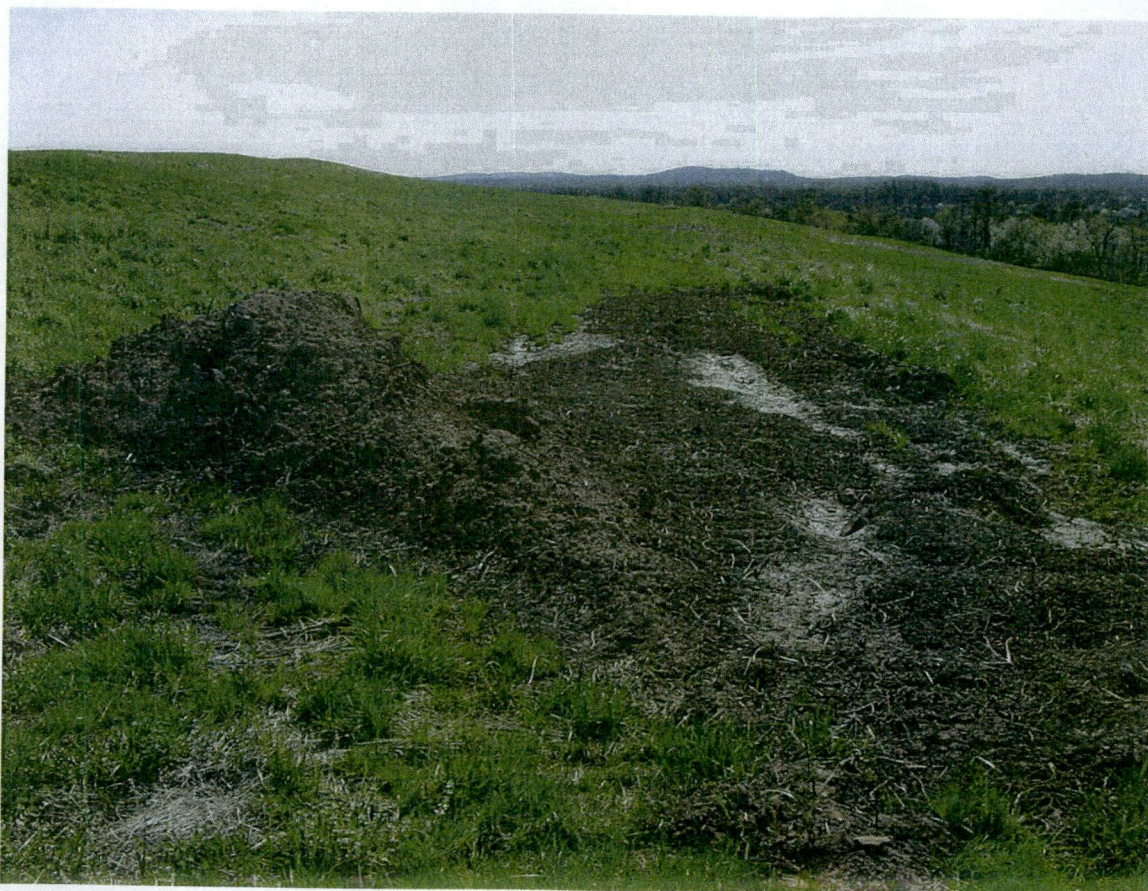
**Photo #19 – View of unvegetated area on the southern side of the landfill (towards the top).**

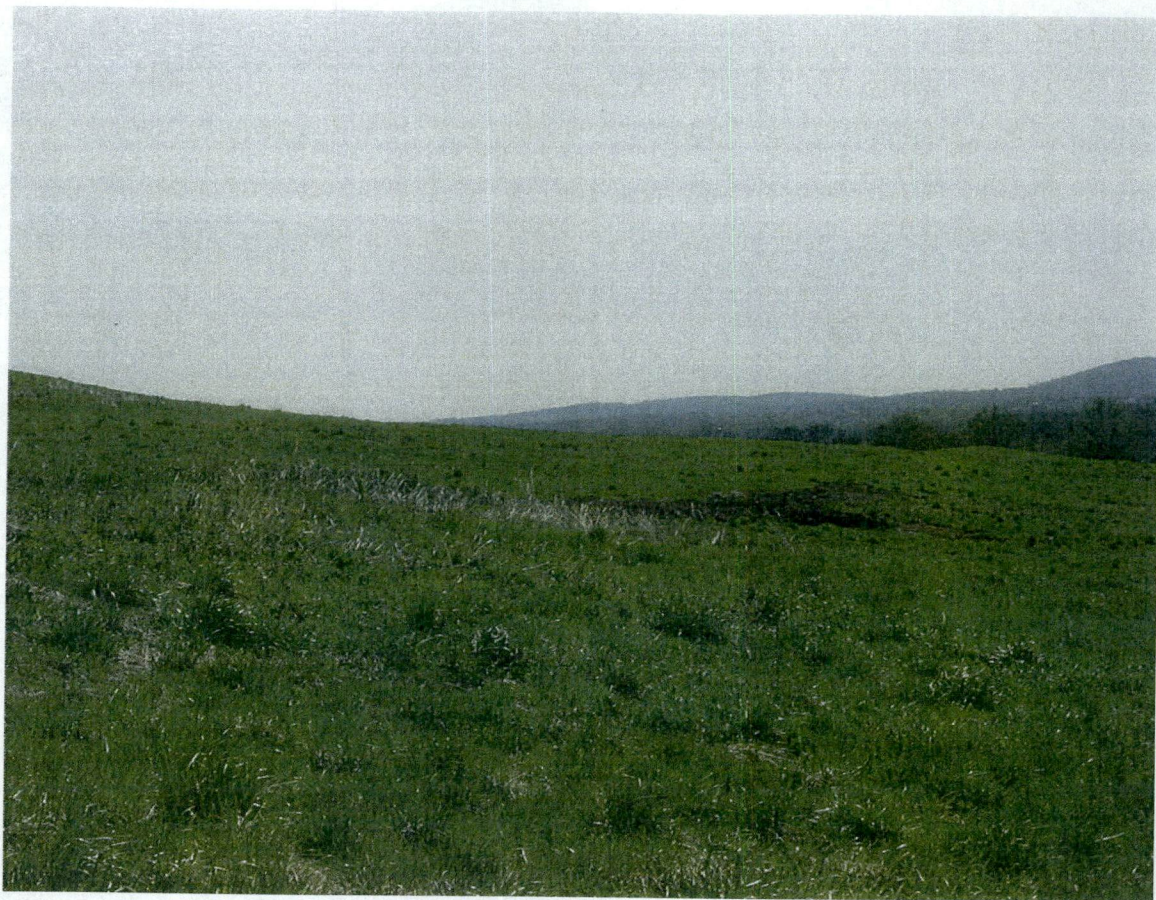
**Photo #20 – View of unvegetated area on the southern side of the landfill (towards the top).**

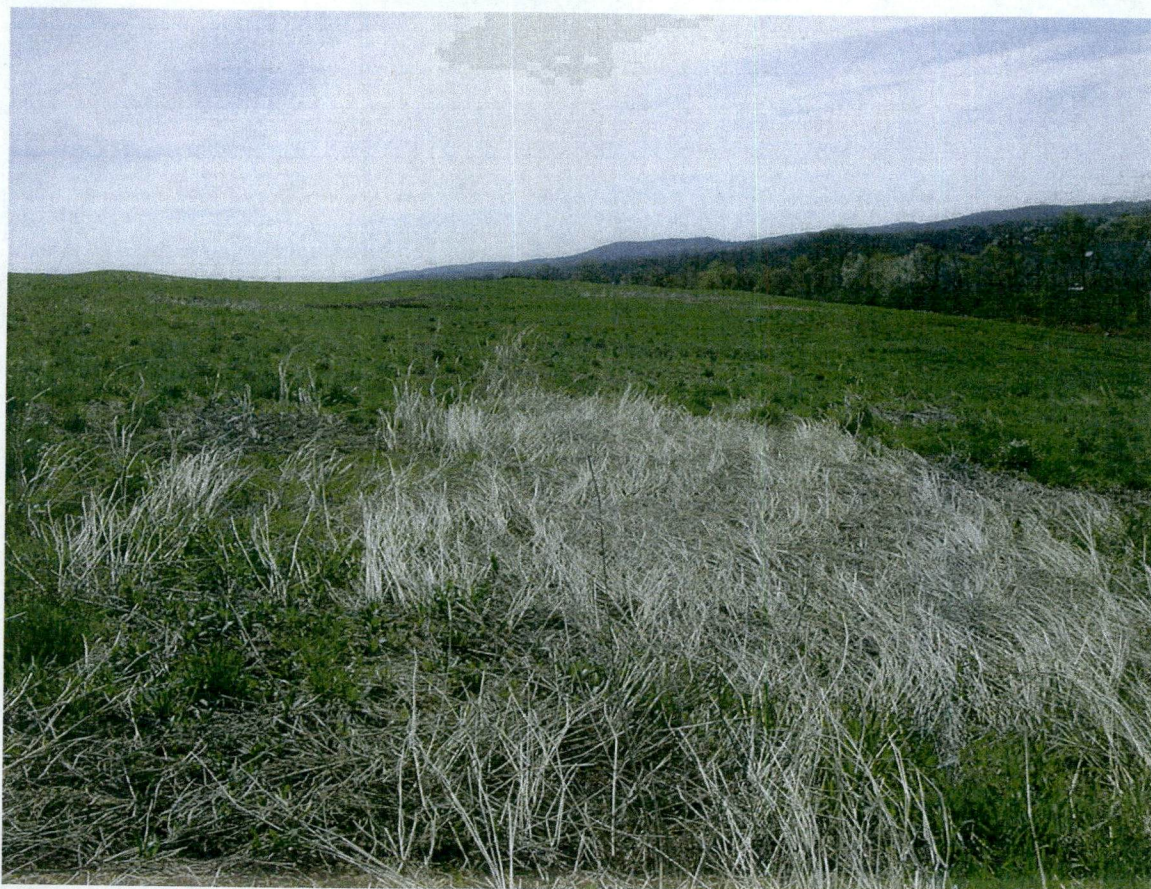
**Photo #21 – Stressed vegetation at the top f the landfill on the southern side.**

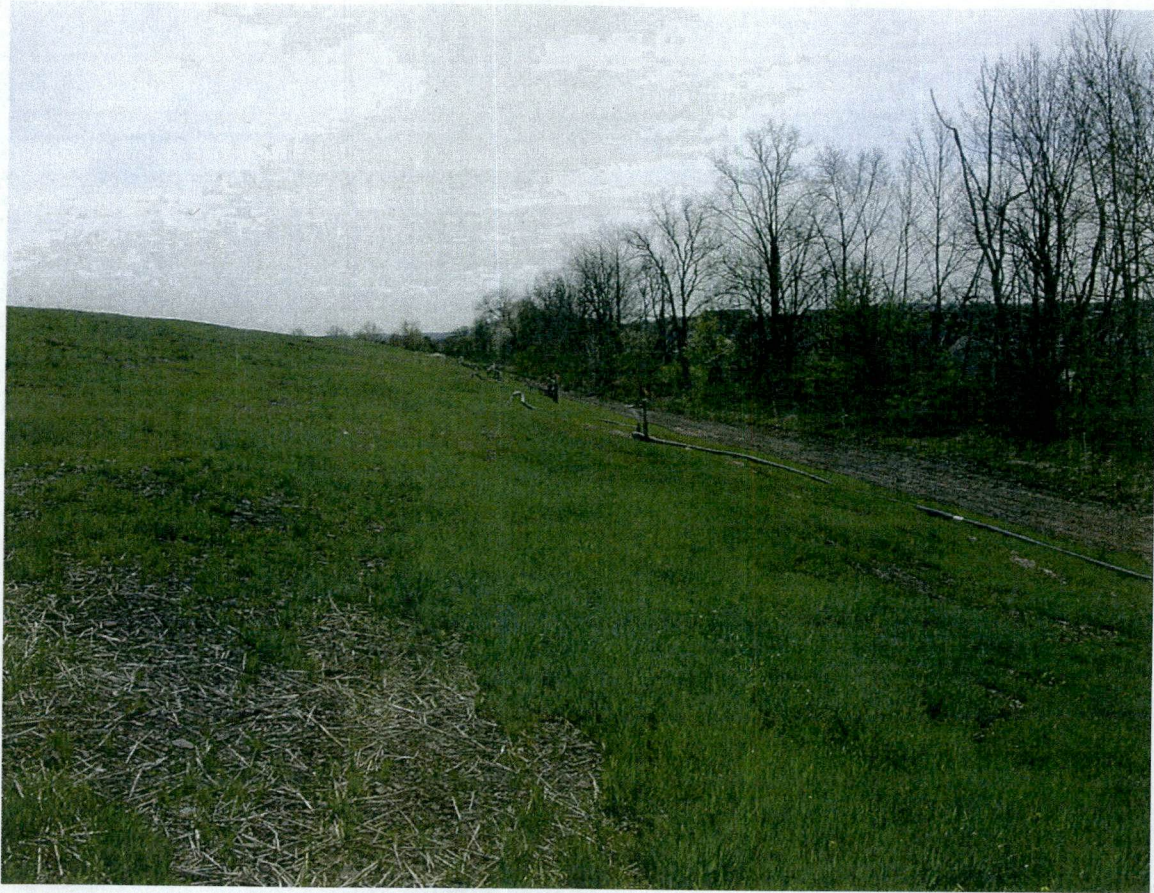
**Photo #22 – View of dirt access road, original vapor recovery piping, and stressed vegetation on the southern side of the landfill.**

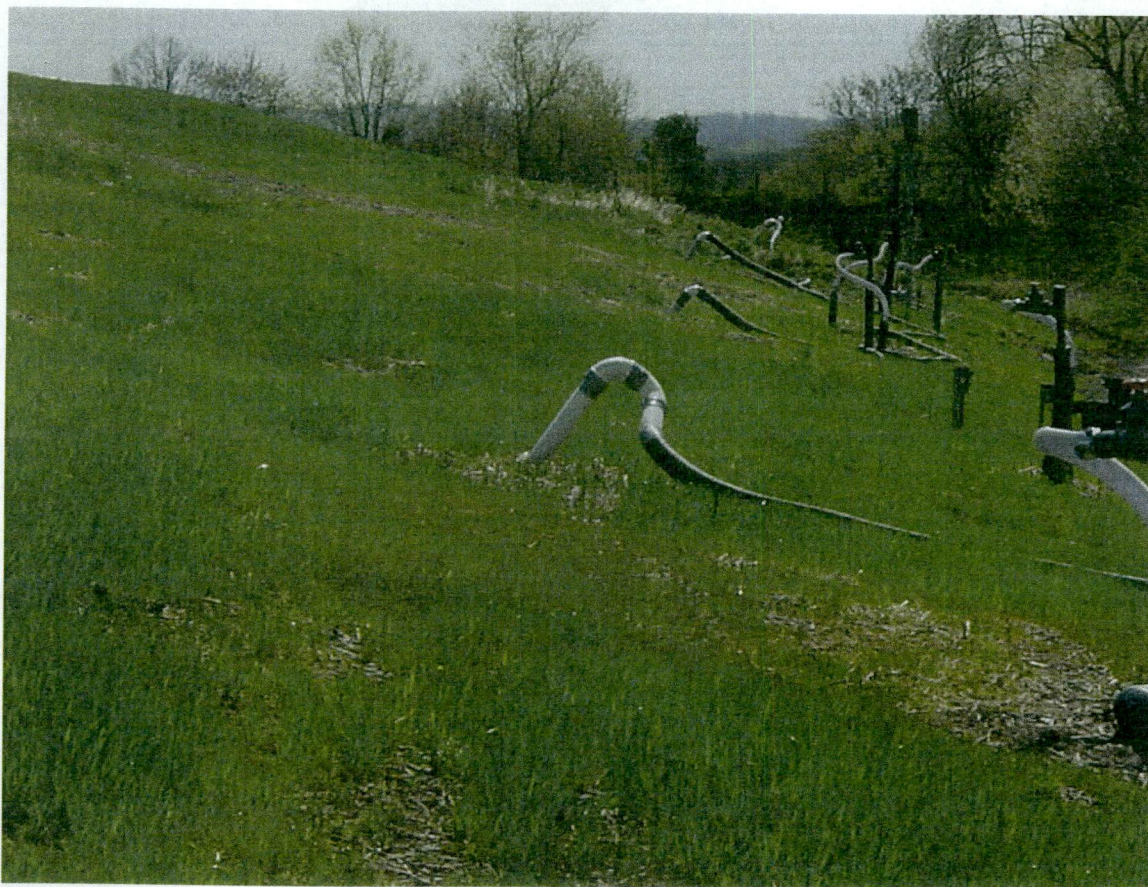
**Photo #25 – View of original vapor recovery piping with duct tape connections.**

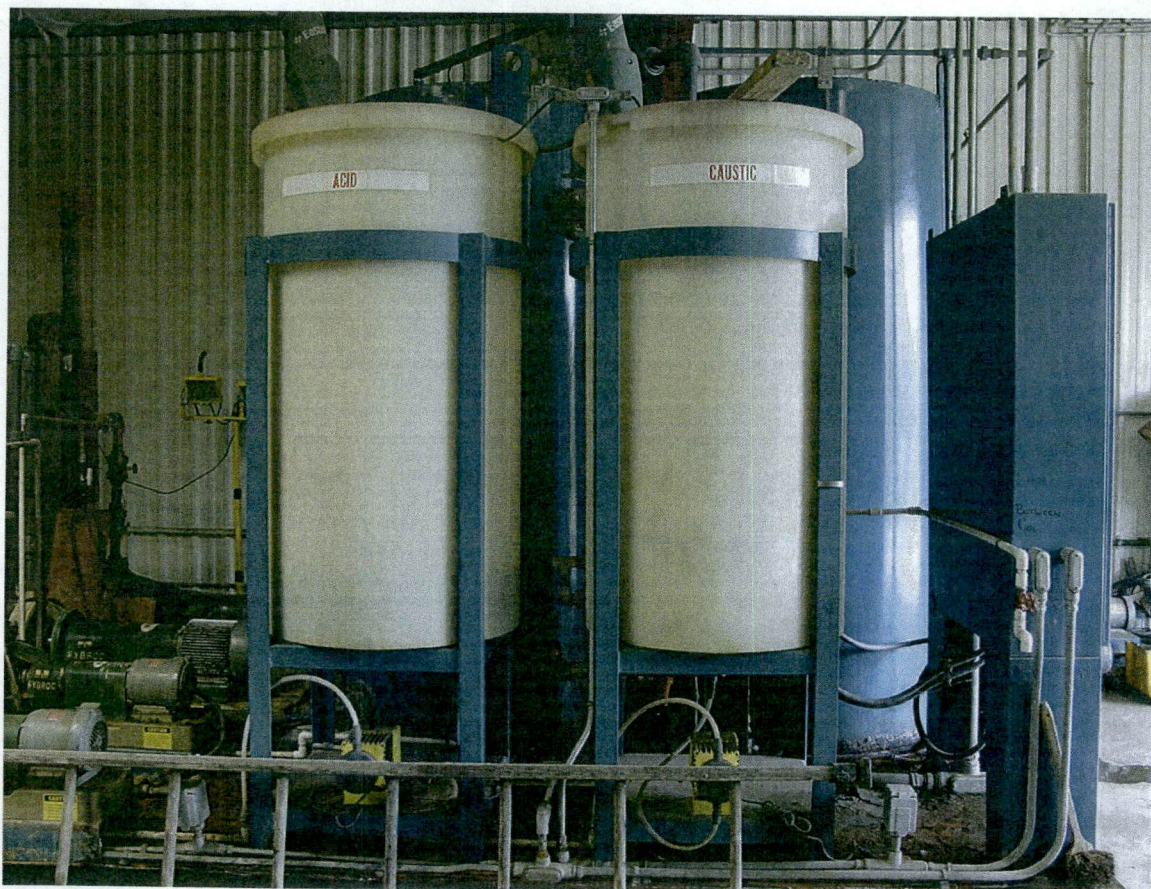
**Photo #30 – View of acid and caustic tanks in the leachate treatment system that are no longer in use.**

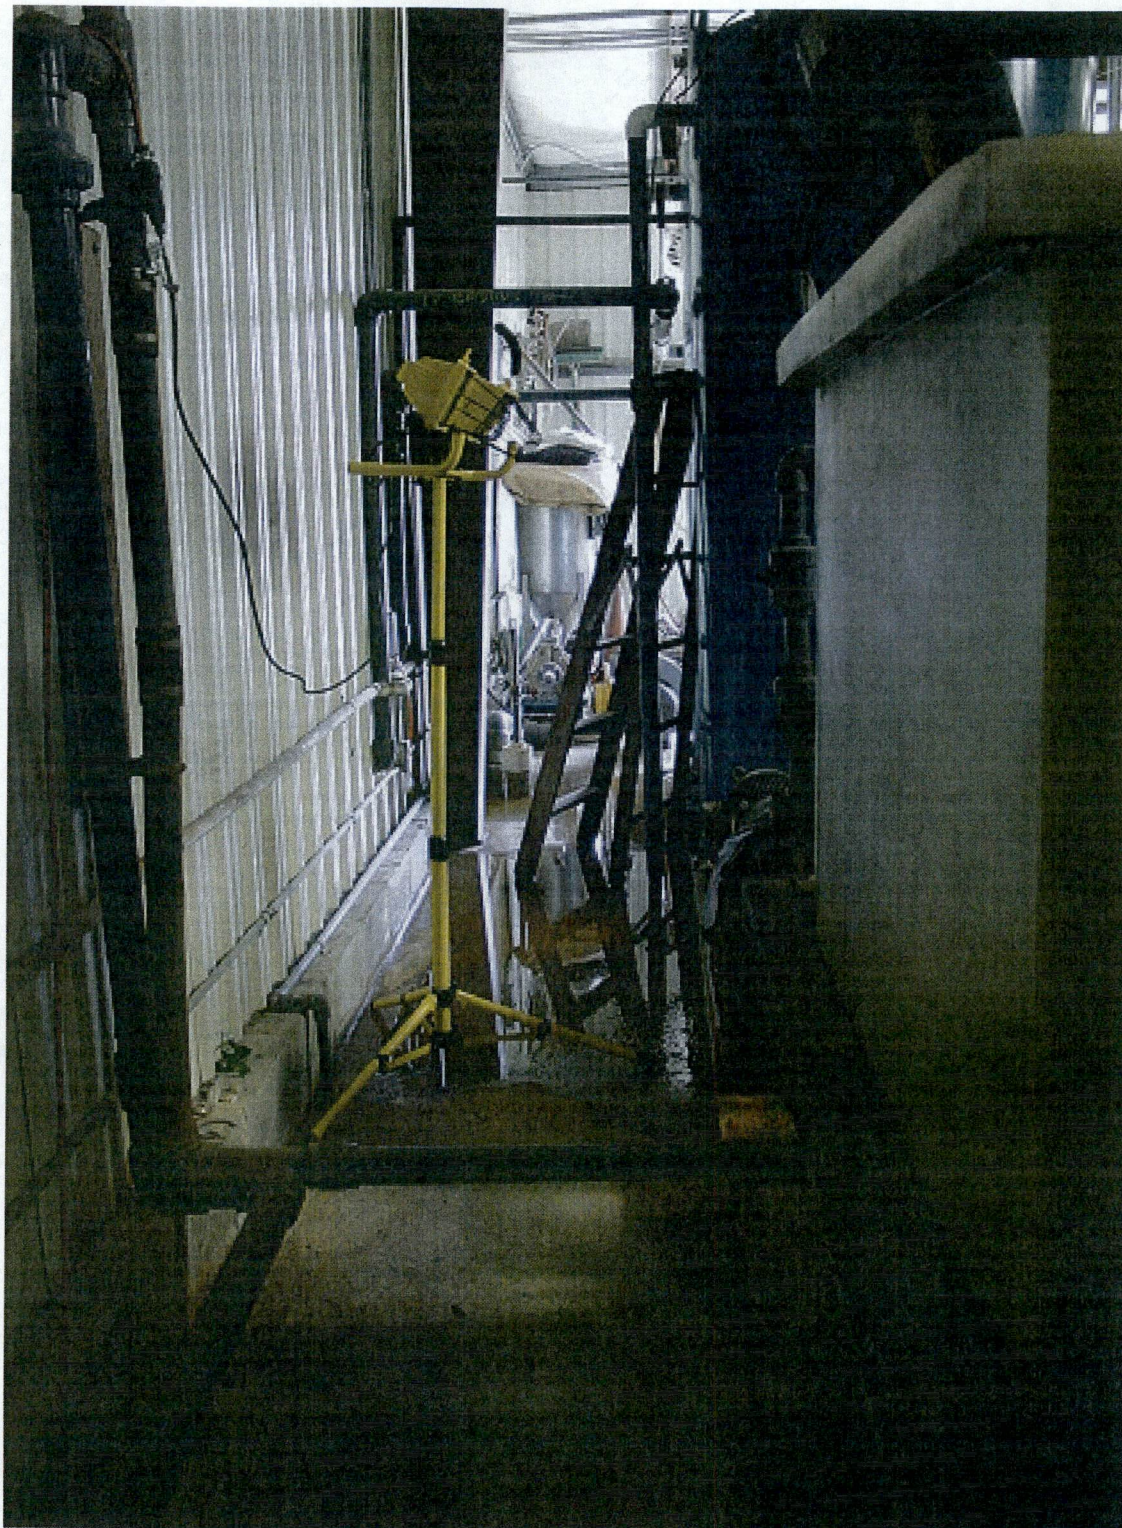
**Photo #33 – View of water leaking from leachate treatment system piping..**

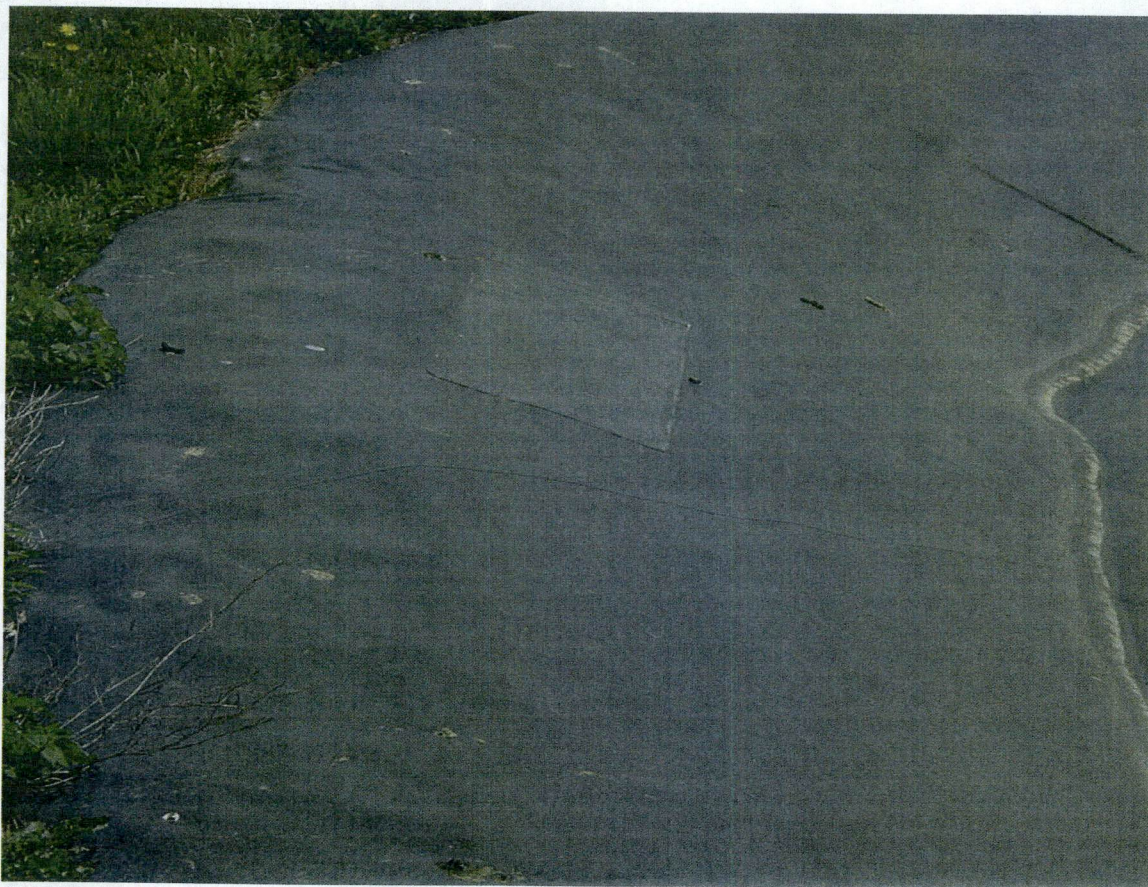
TtFW observed at least 2 feet of freeboard available in each of the three leachate ponds (one influent raw leachate pond and two treated leachate ponds) and several liner patches noticeable along the leachate collection and settling ponds. Therefore, it seems Mr. Frame is providing some degree of maintenance to the treatment plant equipment.

**Photo #42 – View of patch on one leachate holding pond.**
